Rimkus Consulting Group, Inc.
Eight Greenway Plaza, Suite 500
Houston, TX 77046
(800) 580-3228 Telephone
(713) 623-4357 Facsimile

Re: RCG File No: 11009971
LLV Number: 0209452
VMF Location: 1530 Greensmark Drive in Houston, Texas
Subject: Final Report

Rimkus Consulting Group, Inc. was retained to examine LLV 0209452, VIN 1GBCS10E4M2908832. The fire occurred on June 13, 2016 at around 12:30 P.M. the operator of the vehicle at the time of the fire, was unavailable for interview but reportedly stated the vehicle's engine died while delivering mail on his route and backfired during subsequent attempts to restart it. Soon thereafter, smoke was observed from beneath the hood as well as flames.

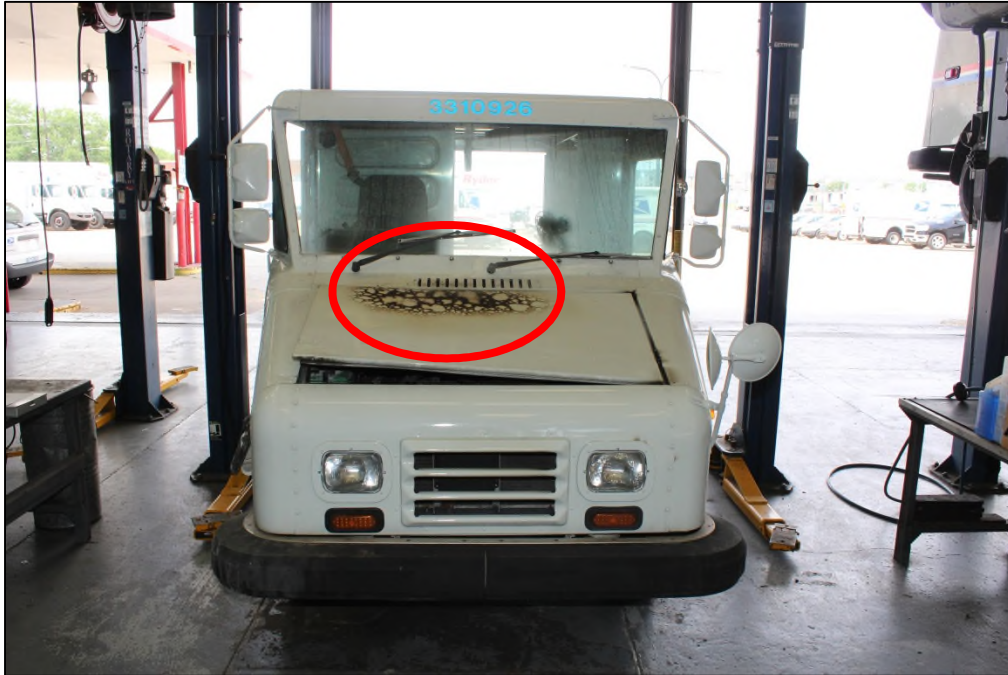
Photograph 1

Examination of the vehicle began at the front exterior and continued in a clockwise direction. A radial fire pattern was present near the center, rear of the vehicle's hood. Based on the fire patterns observed, it was determined the fire originated inside the engine compartment.

Radial type fire pattern on vehicle's hood.

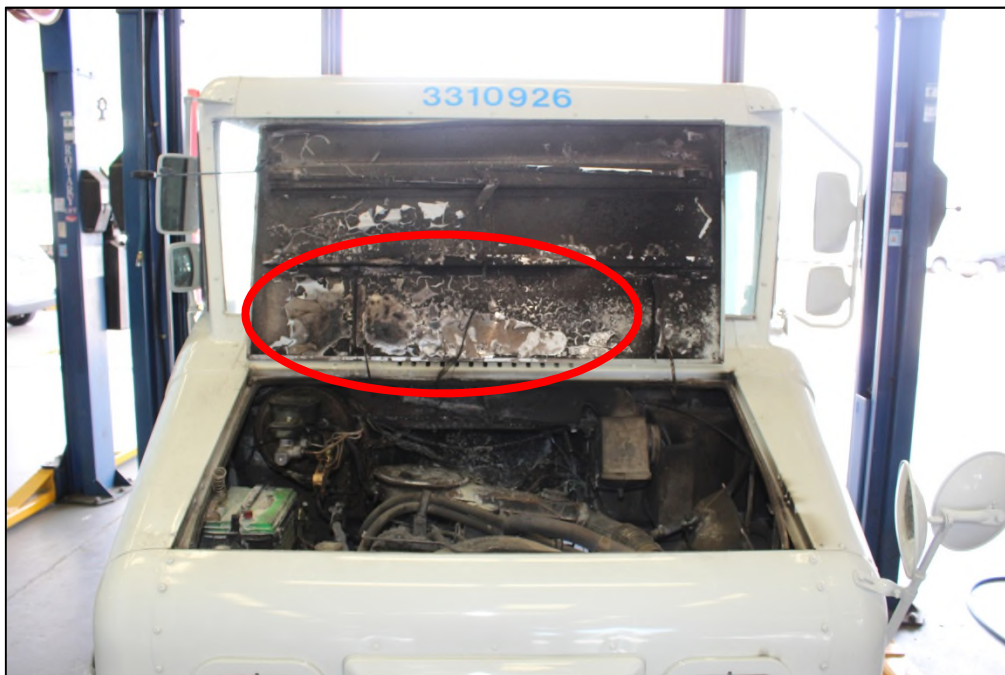
Photograph 2

A fire pattern was observed on the underside of the vehicle's hood. The pattern indicated that the fire originated on the driver's side of the engine compartment below the vehicle's bulkhead where the distributor was mounted to the side of the engine. The fire communicated upward causing damage to the vehicle's hoses and electrical wiring harness.

Underside of vehicle's hood, note fire pattern.

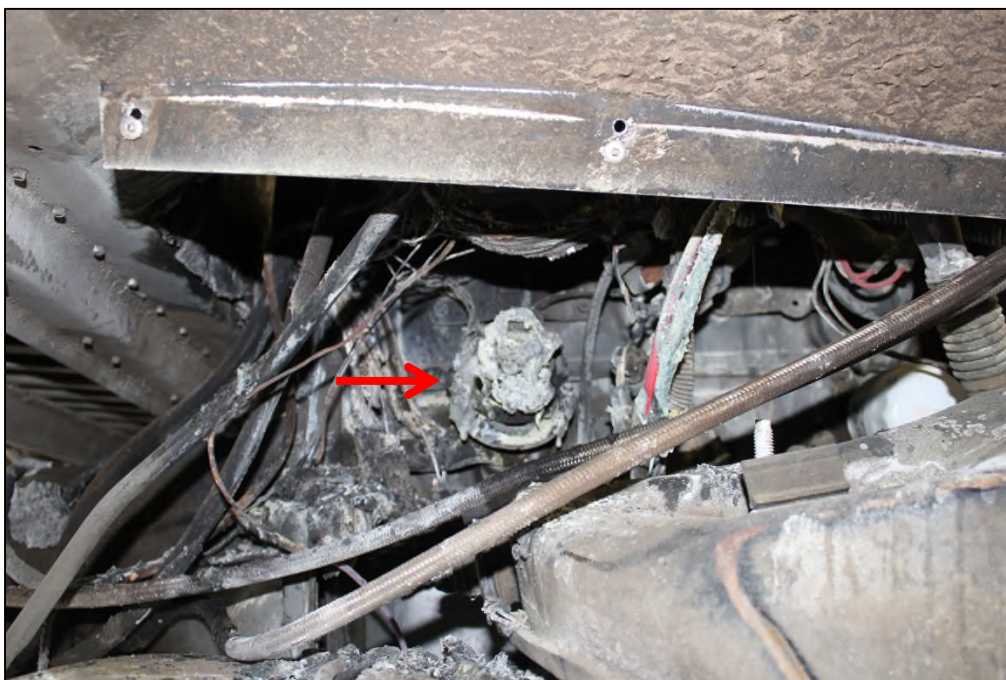
Photograph 3

Based upon fire patterns and the remaining physical evidence, it was determined that the fire originated at the Driver's side, rear of the engine compartment where the vehicle distributor is mounted to the engine. The distributor was severely damaged and the cap was completely consumed. A fire pattern was observed on the side of the engine where the distributor was located. The observed pattern indicated that the fire communicated upward causing damage to the vehicle's hoses and electrical wiring harness.

Area of origin where distributor was located.

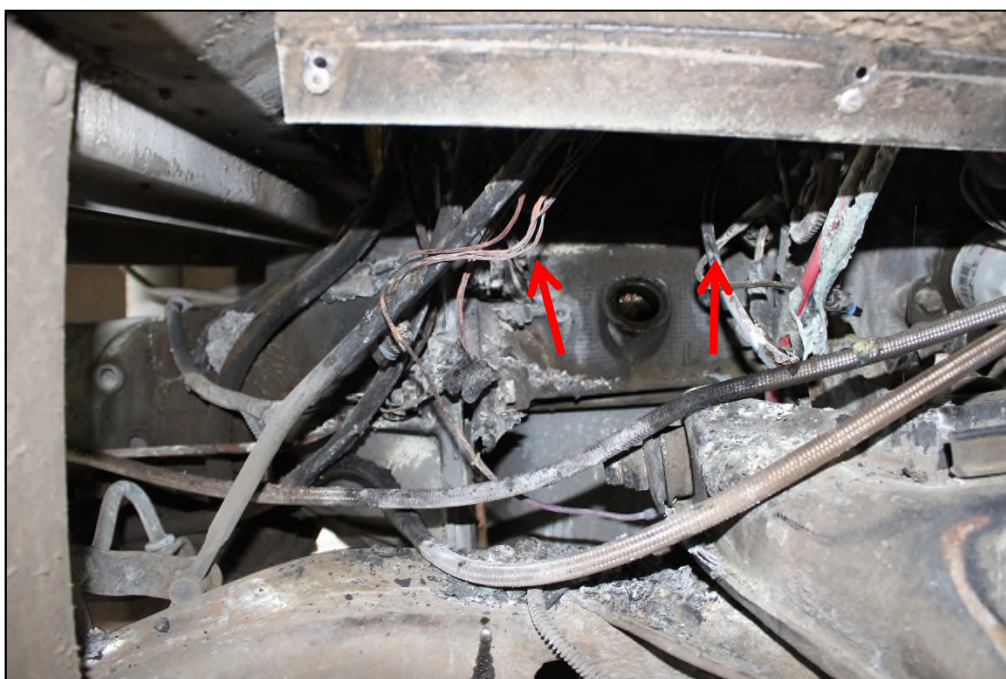
Photograph 4

Area of origin with distributor removed, note fire pattern.

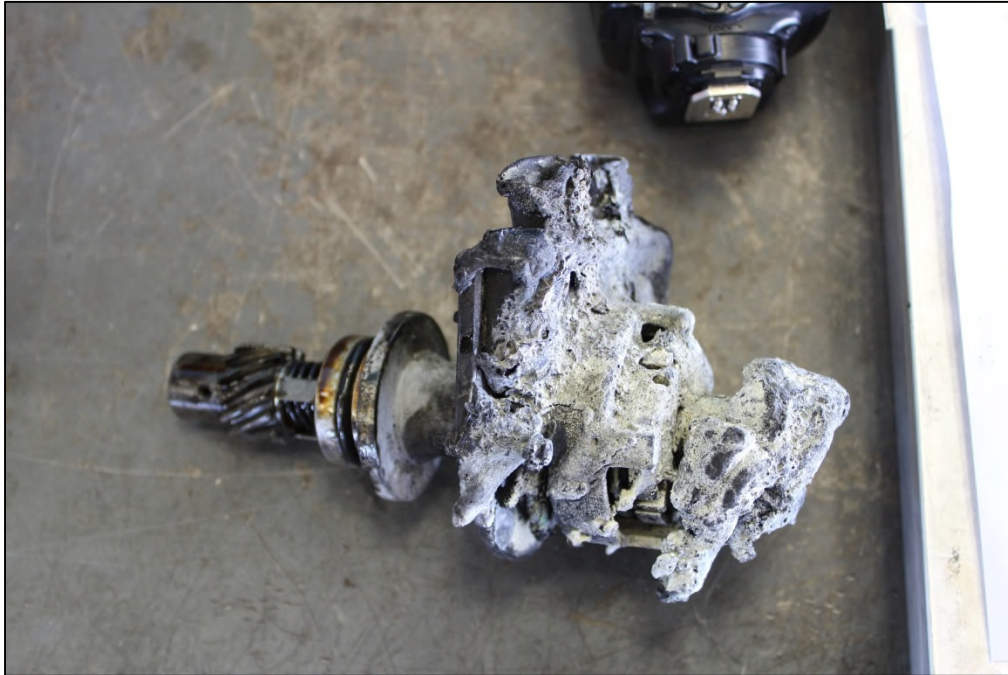
The vehicle having trouble starting and "stalling" several times is a symptom of a malfunctioning distributor. The continued operation of the vehicle caused the rotor to overheat causing the fire event.

Photograph 5
Damaged distributor.

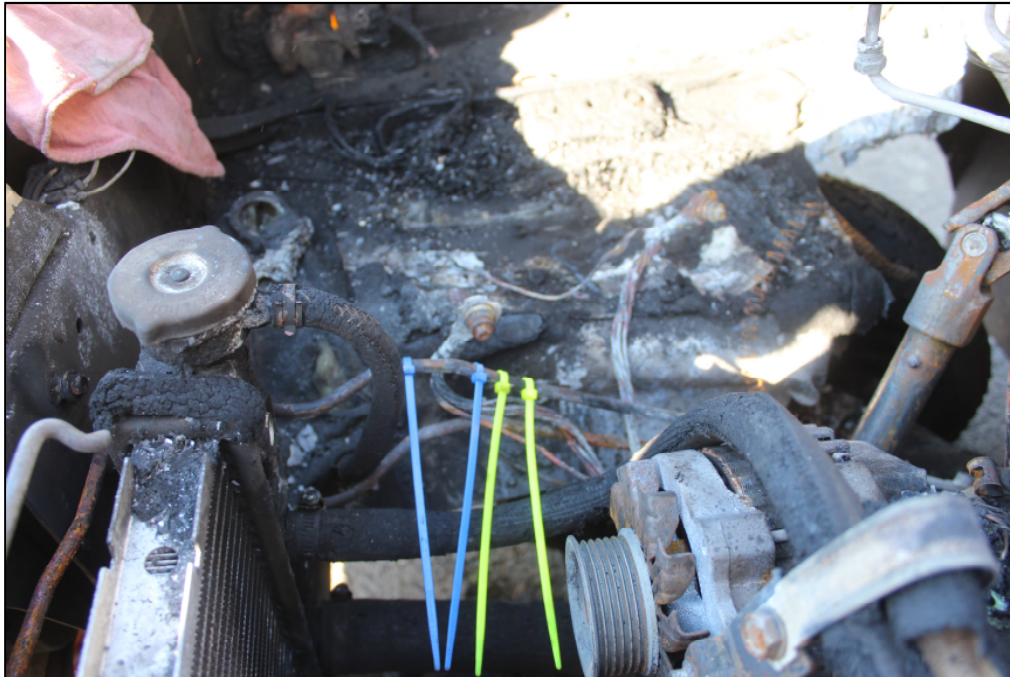
Photograph 3

Arcing observed the vehicle brake lines.

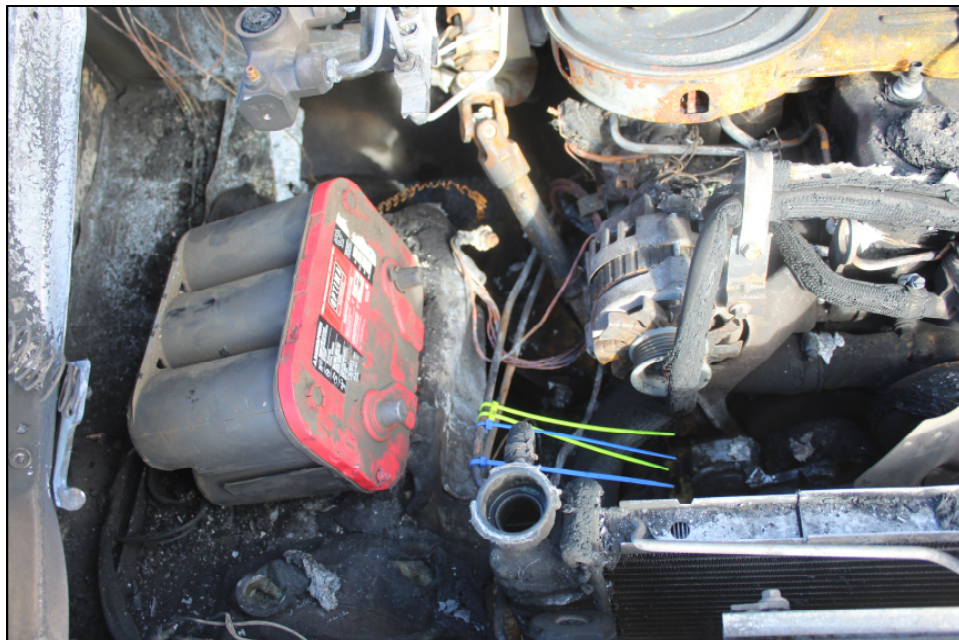
Photograph 6

Exemplar battery showing position prior to fire incident; note the position of the battery terminals.

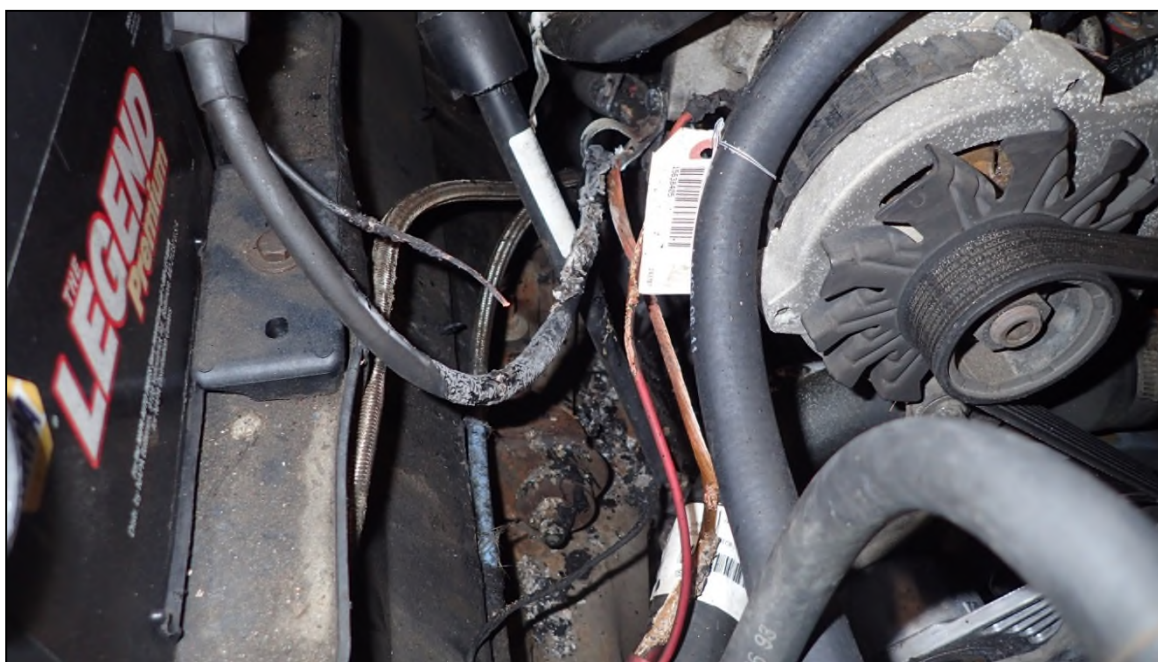
Photograph 4

View of the fire origin.

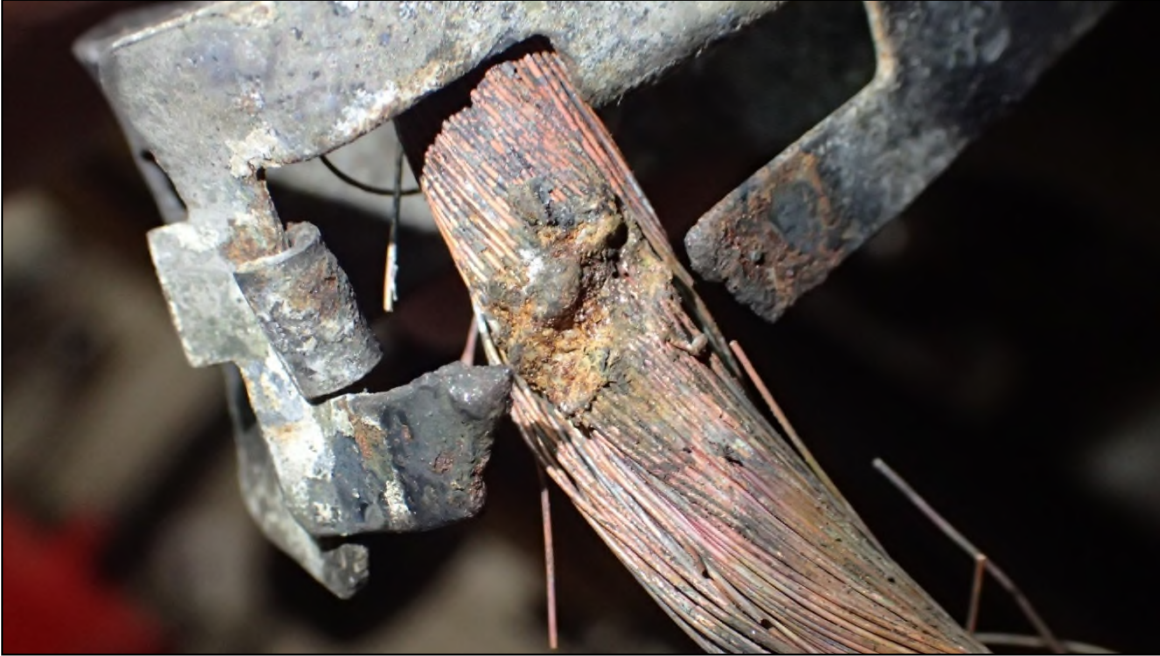
Photograph 5

View of the positive battery cable and P-clamp.

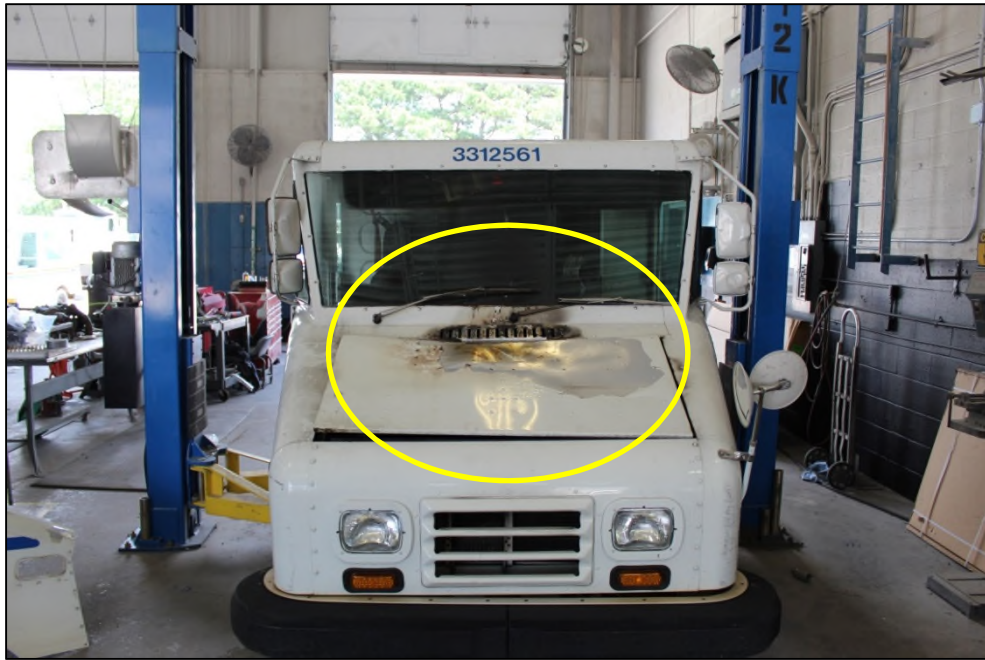
Photograph 1

LLV 3312561, observe the heat damage to the center hood area.

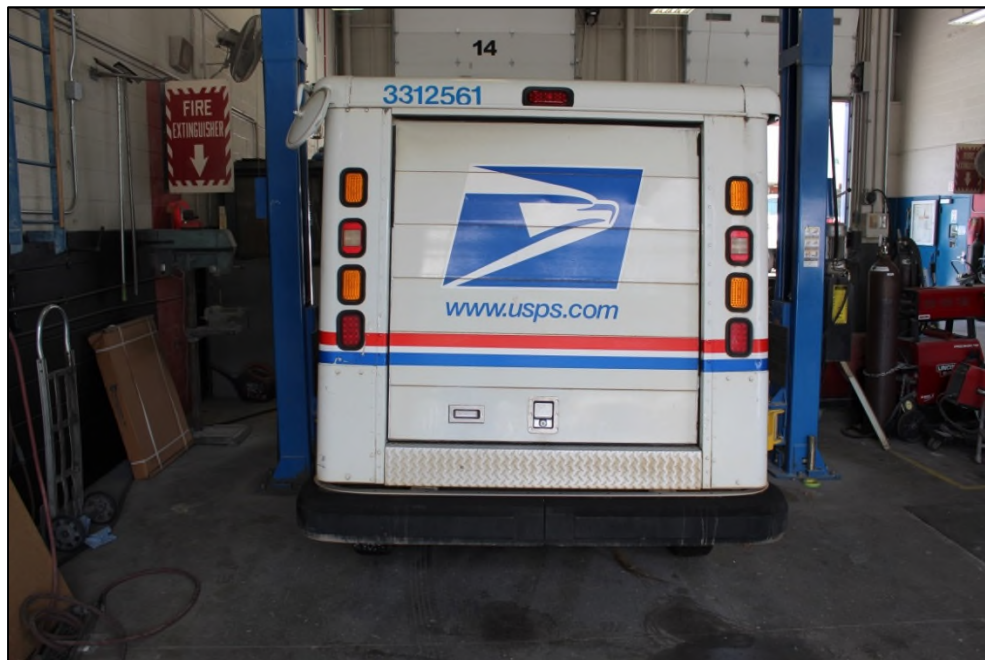
Photograph 2

Rear cargo area of the vehicle, no fire damage.

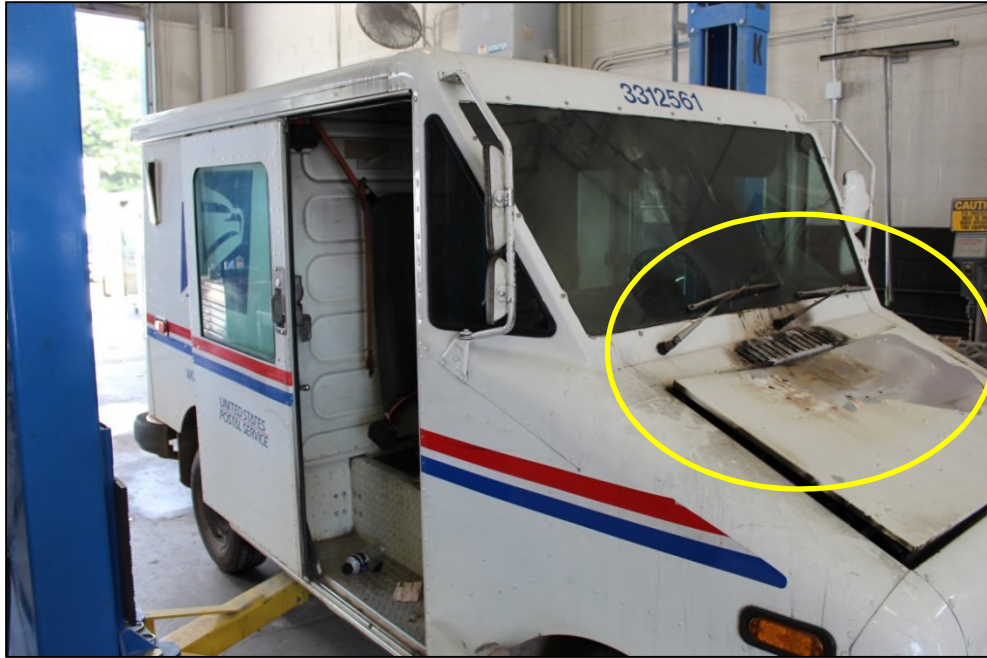
Photograph 3

Observe the damage to the hood area coming from the engine compartment.

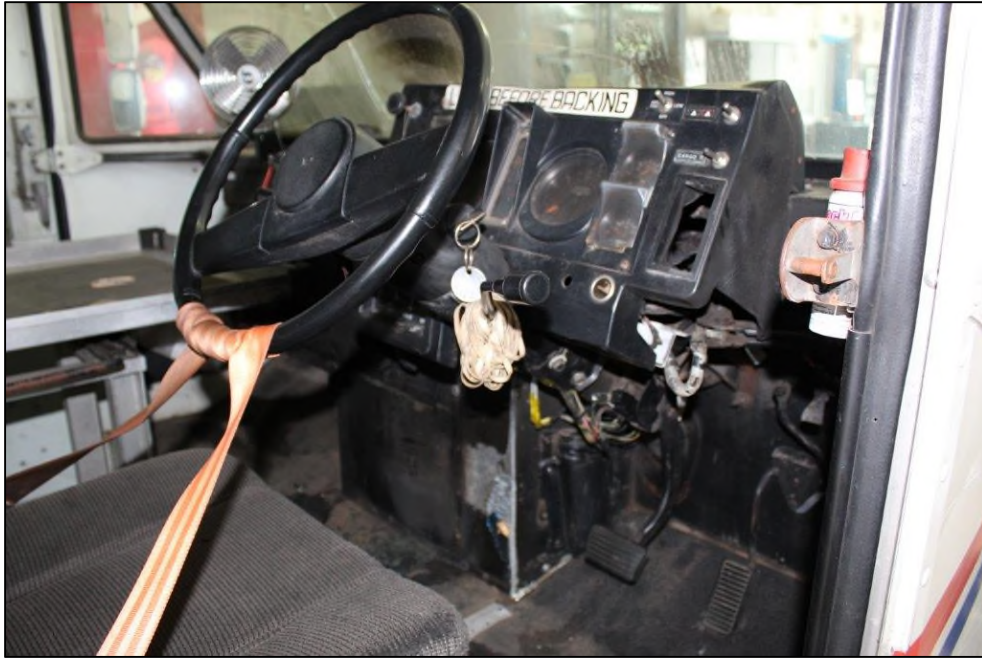
Photograph 5

Interior of the vehicle, only damage was the progression from the engine compartment.

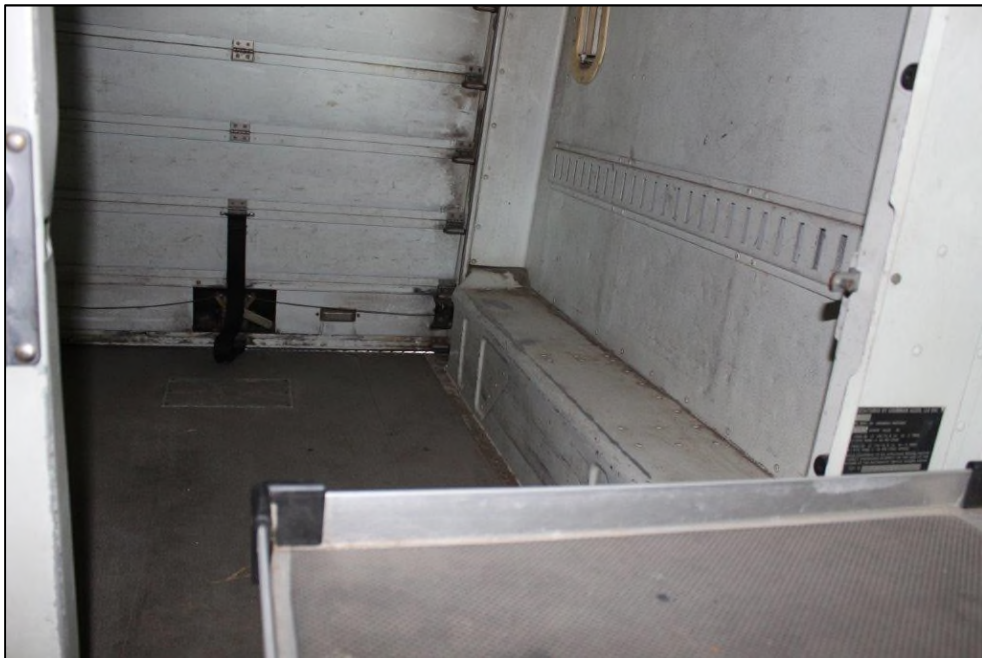
Photograph 6

Cargo area, no damage.

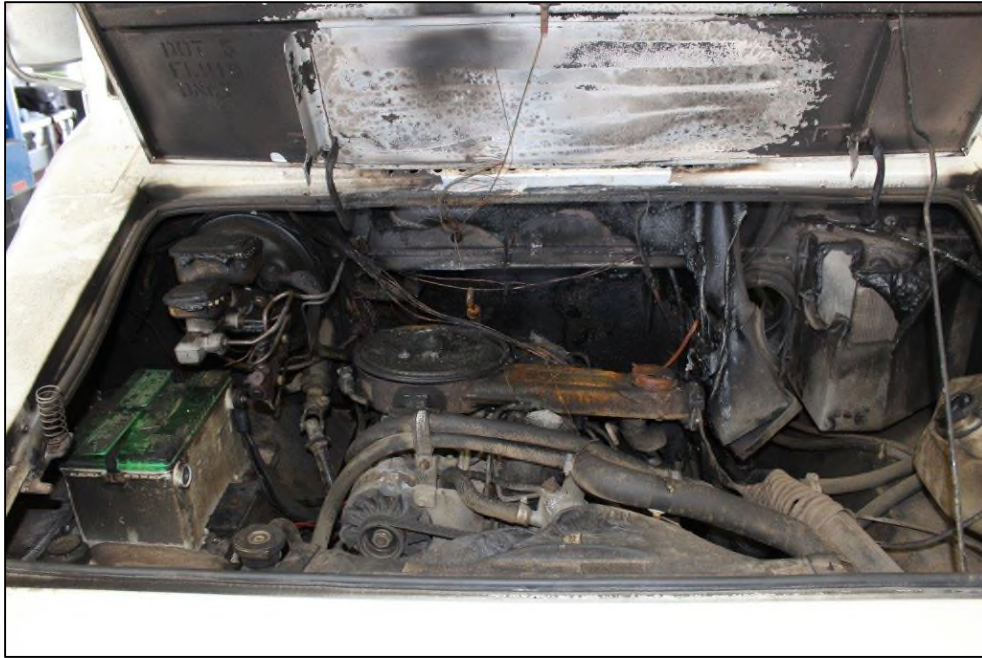
Photograph 7

Engine compartment, observe the damage directly above the air filter.

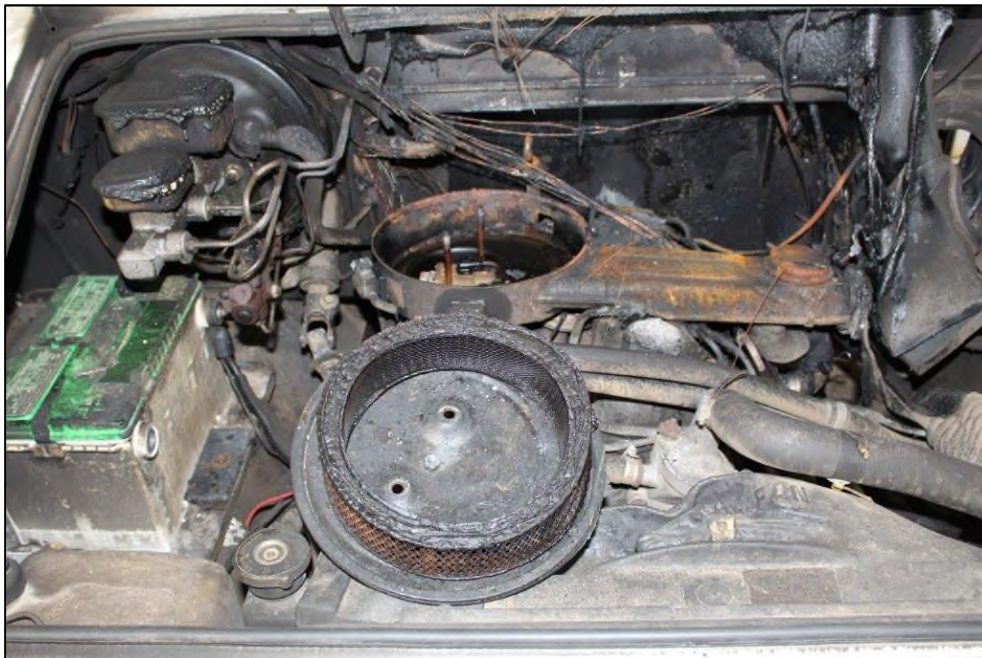
Photograph 8

The air filter observed improperly installed with no fasteners.

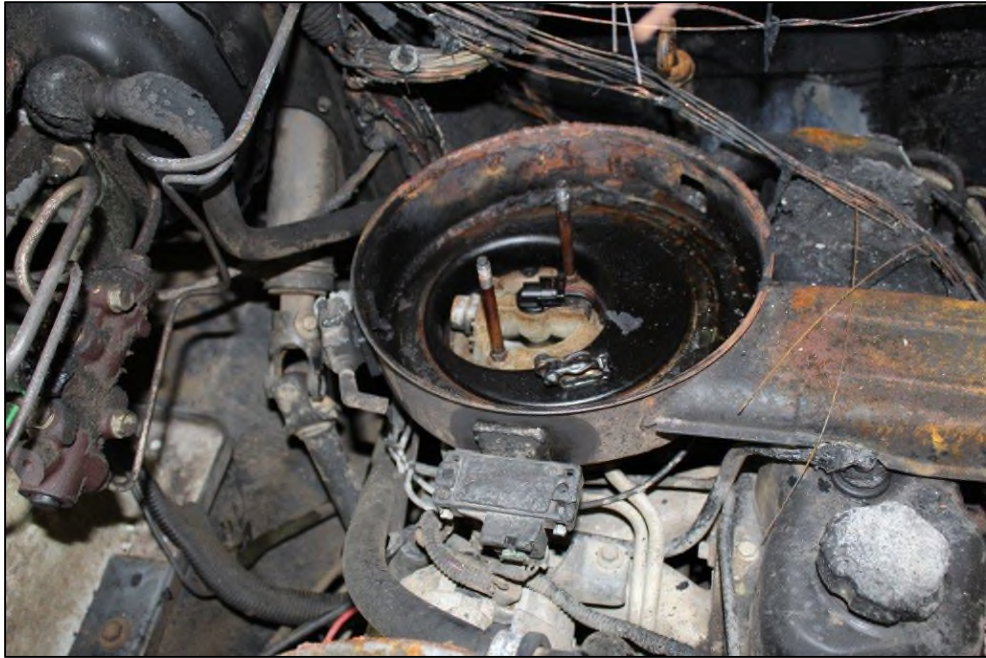
Photograph 9

The fuel injection system and air filter, observe the fire damage to the area.

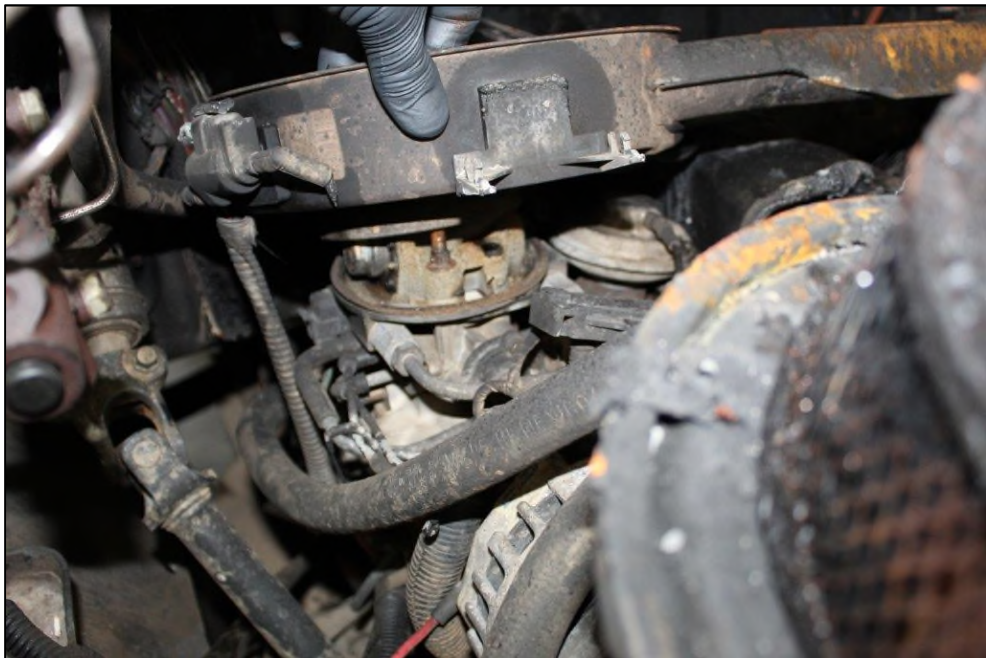
Photograph 10

The fuel injection system, observe the fire damage to the area.

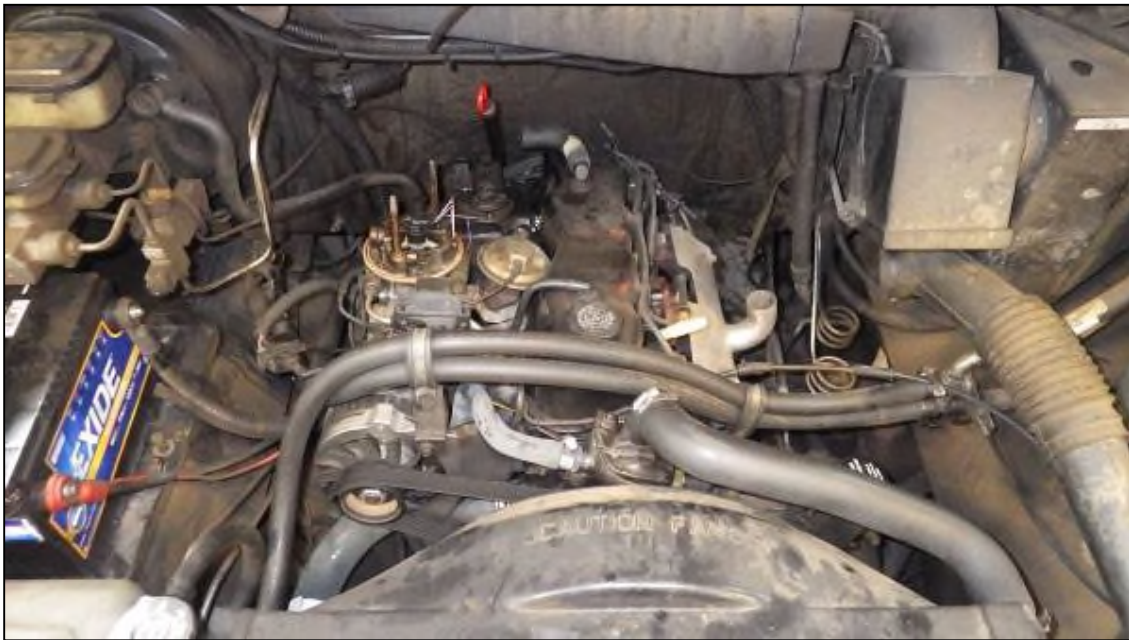
Photograph 4

View of the smoke patterns on the bulkhead in the engine compartment.

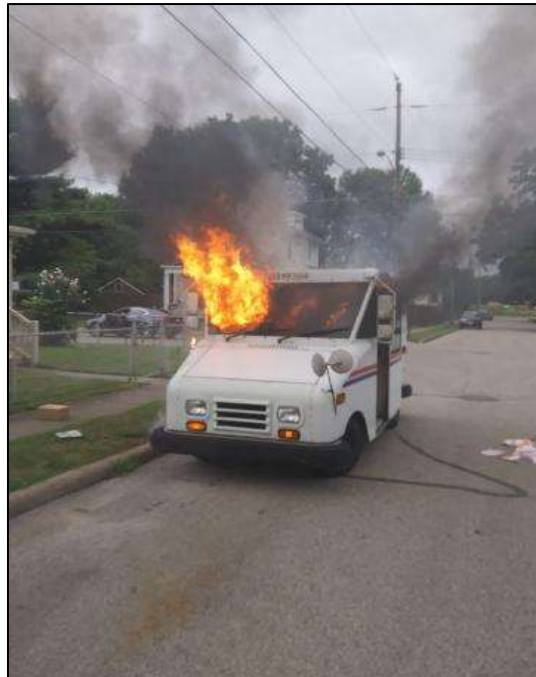
Photograph 1

Photo provided by the carrier driver of the fire at the scene on the route.

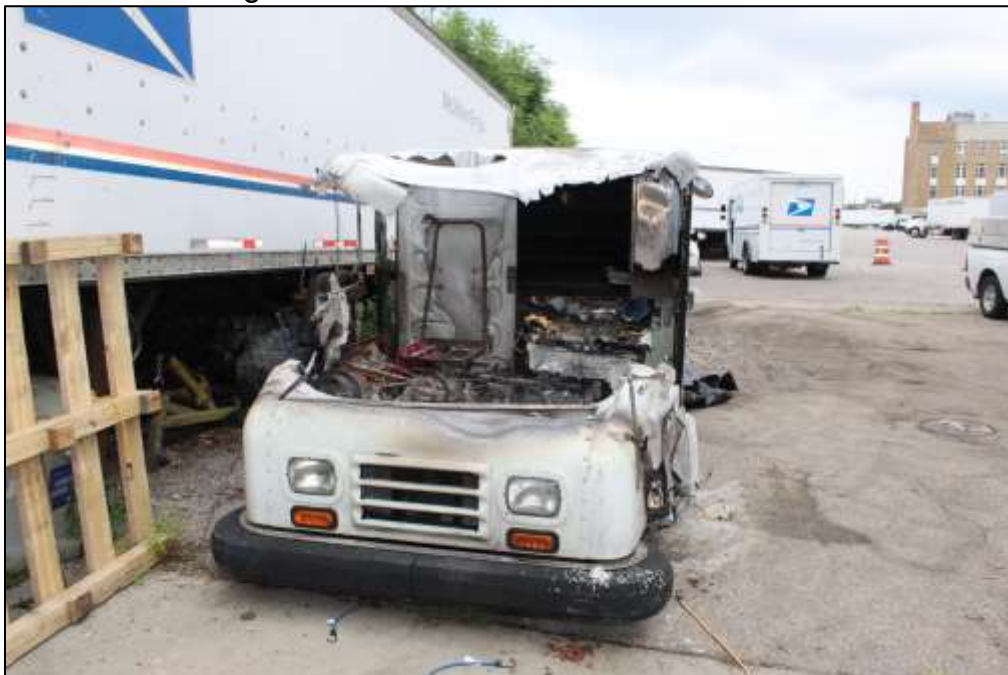
Photograph 2

Remains of the fire damaged LLV at the VMF in Cincinnati.

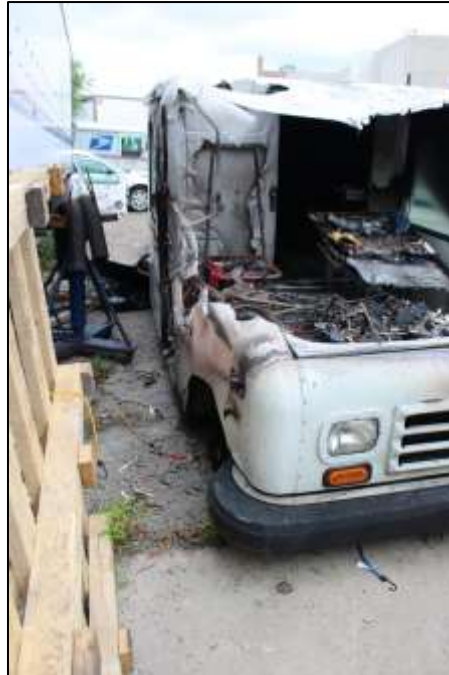
Photograph 3

Driver side with area of fire origin at dashboard.

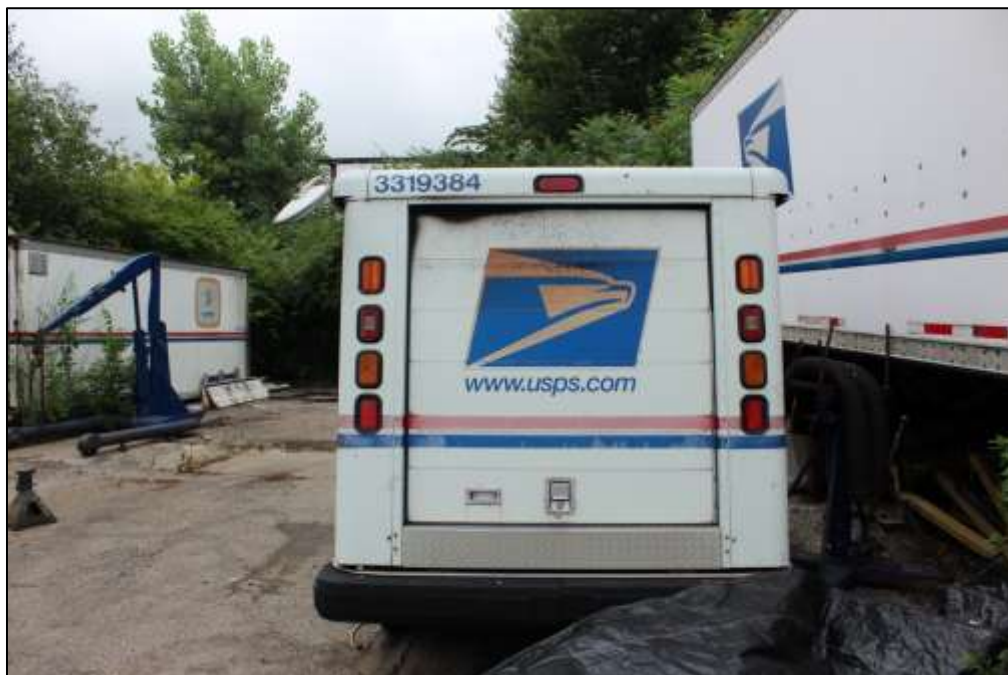
Photograph 4

Rear of LLV.

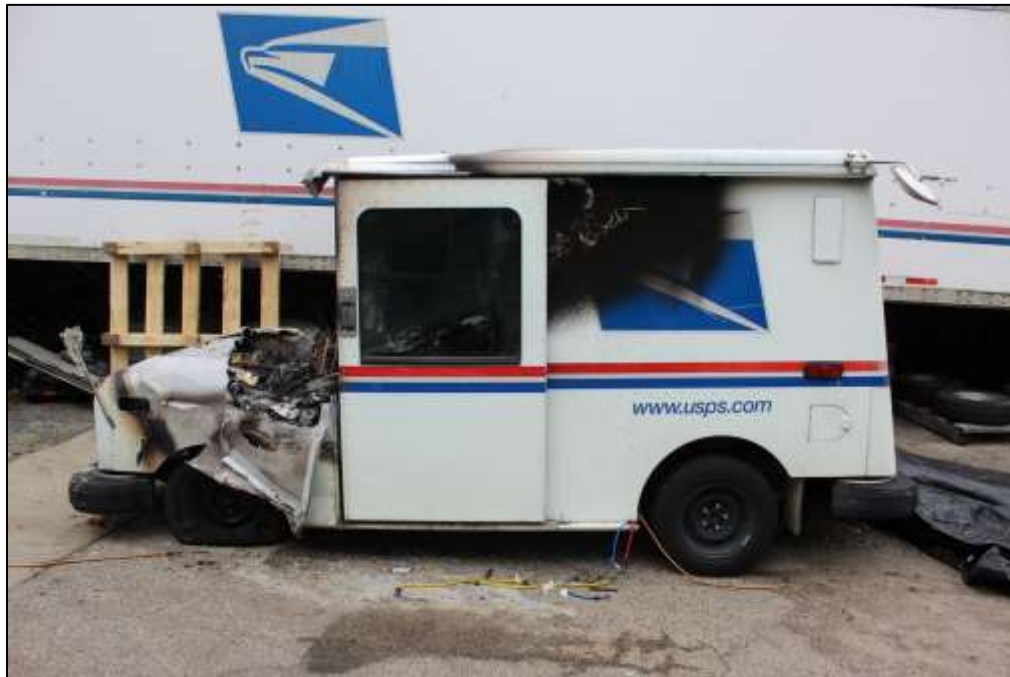
Photograph 5
Mail side of LLV.

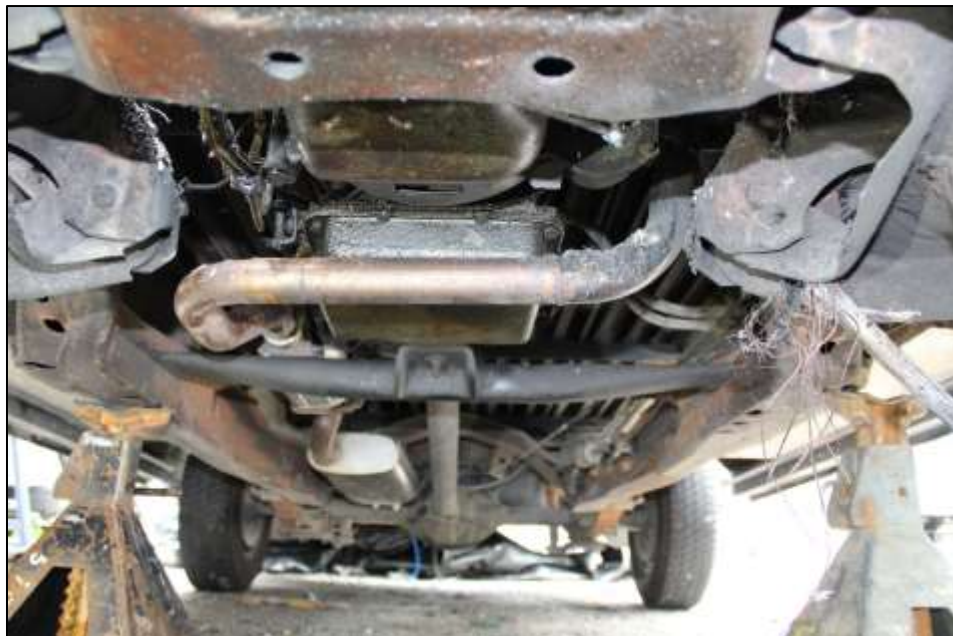
Photograph 6
Undercarriage of LLV.

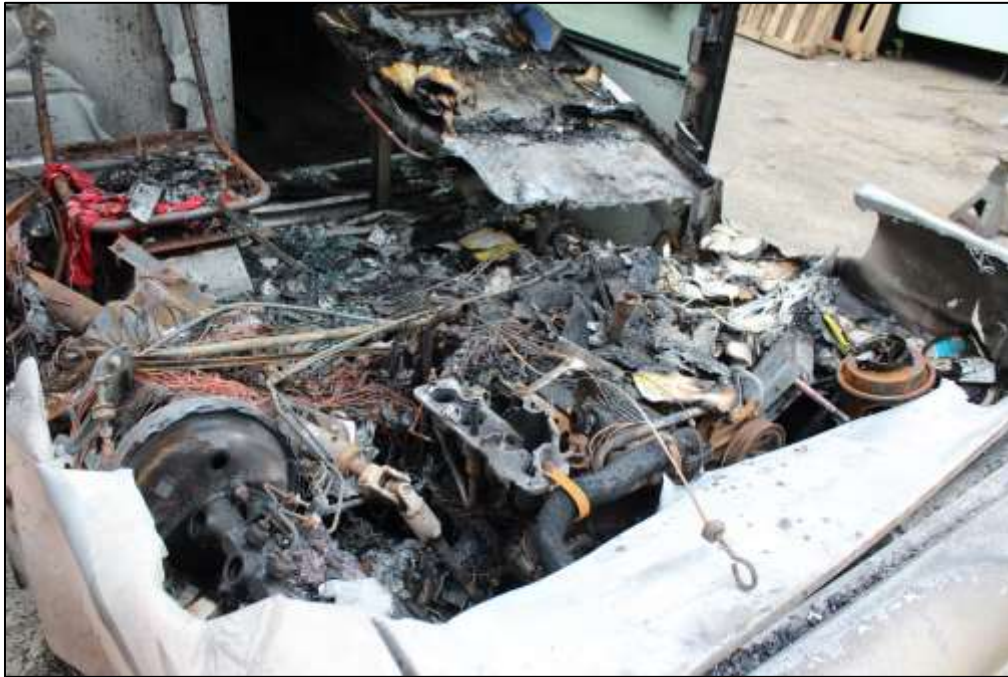
Photograph 7
Engine compartment of LLV.

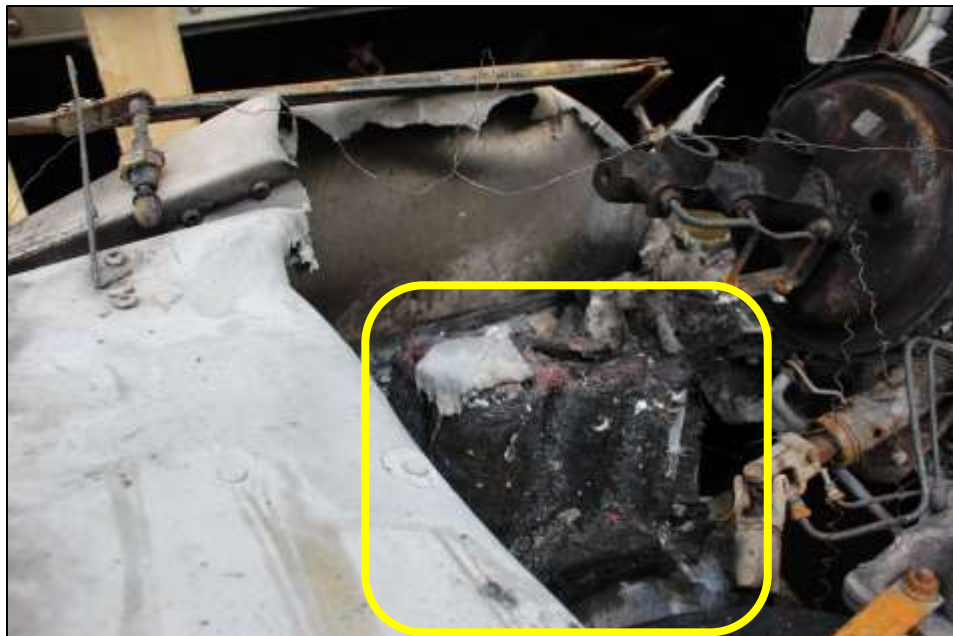
Photograph 8
Battery in engine compartment.

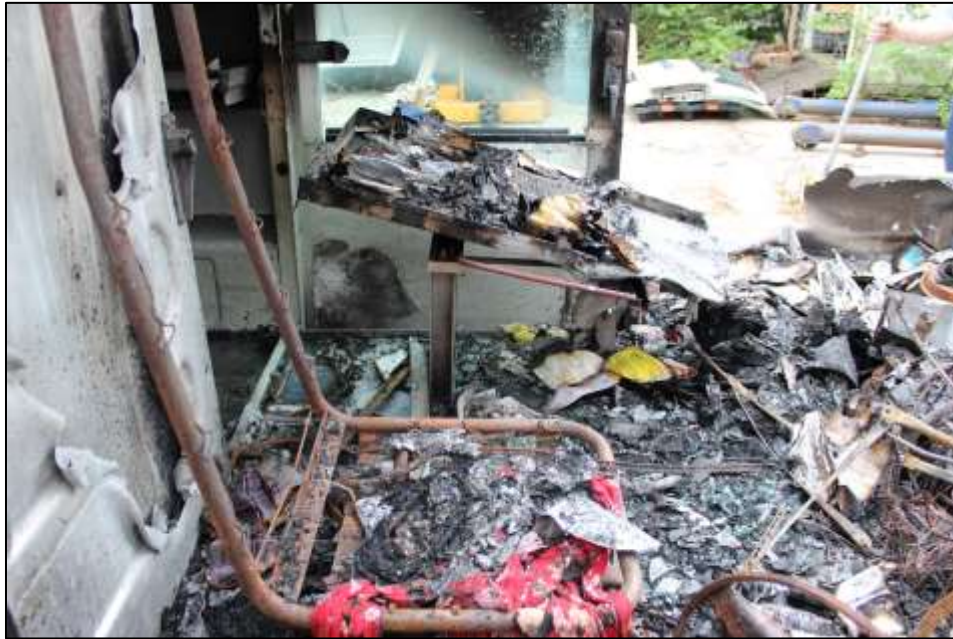
Photograph 9
Driver compartment of LLV.

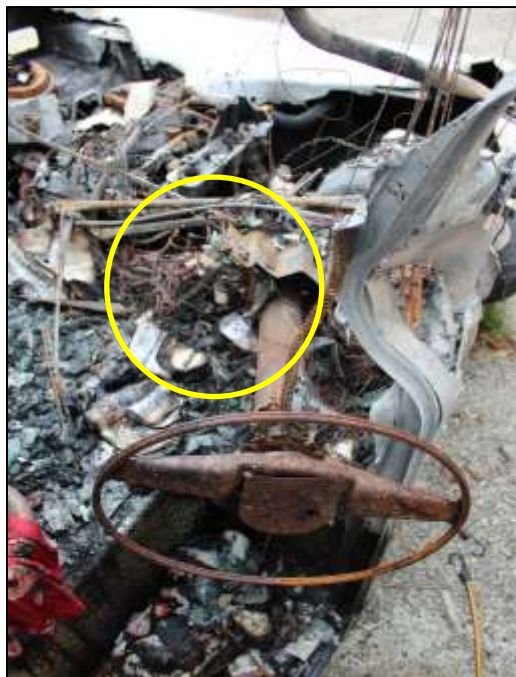
Photograph 10
Driver compartment of LLV, area of fire origin.

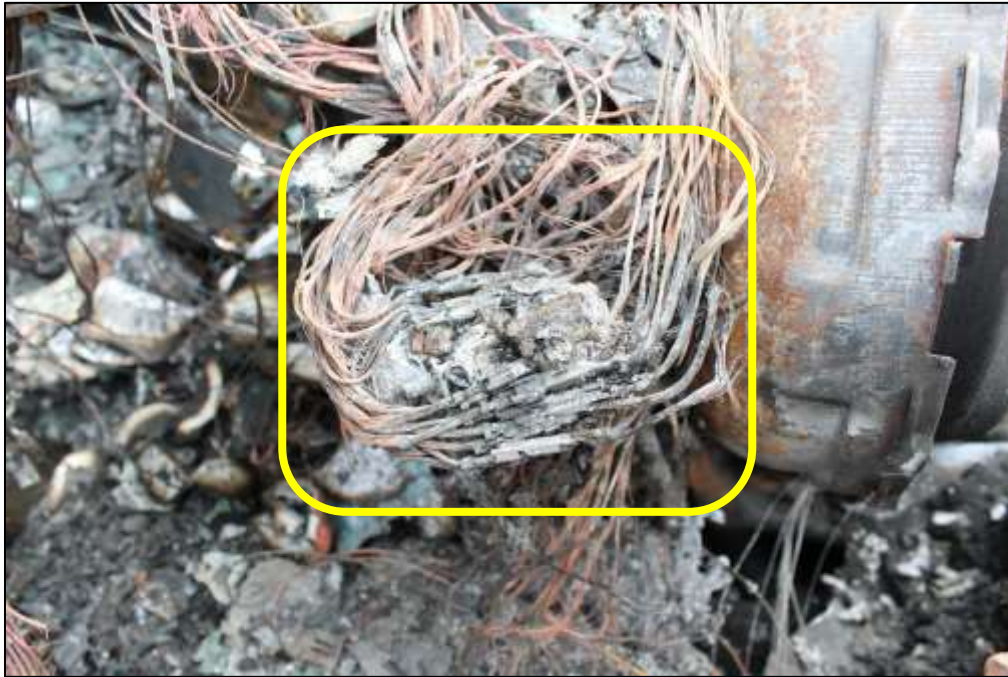
Photograph 11

Remains of the fuse panel in the driver compartment of LLV.

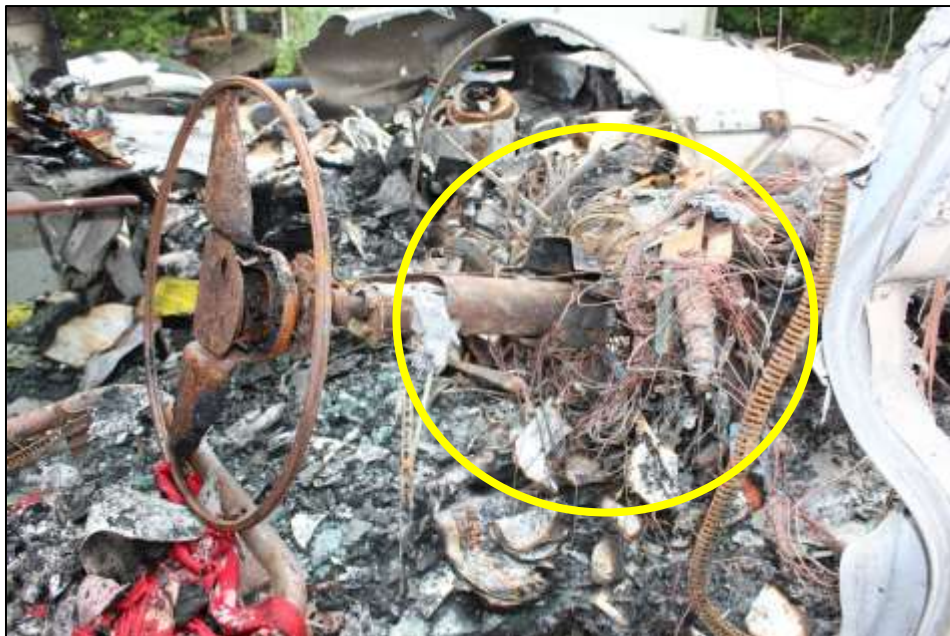
Photograph 12

Driver compartment of LLV, area of fire origin.

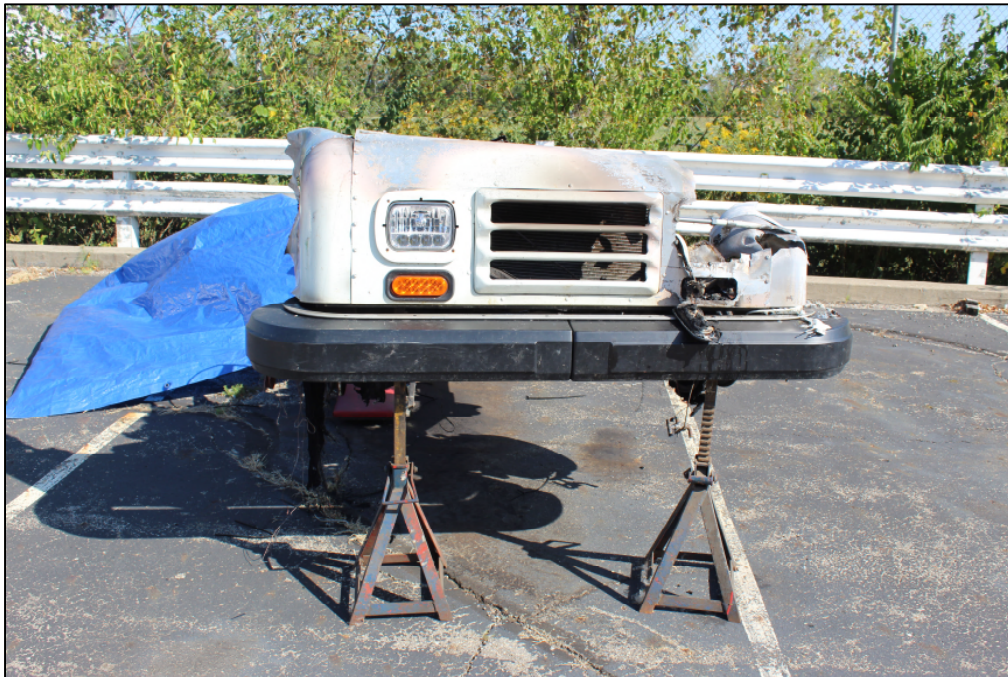
The LLV was observed with severe fire damage and mass loss to all areas of the vehicle. The remains of the frame, with engine and wheels, were located on jack stands in the parking lot. The front bumper and a section of the grill were still attached to the frame. Shredded fire damaged tires were observed on the right side wheels. The rear bumper was still attached to the frame. The remaining fire damaged structural components were stacked on a pallet and in three large trash bins.

Photograph 1
Front view.

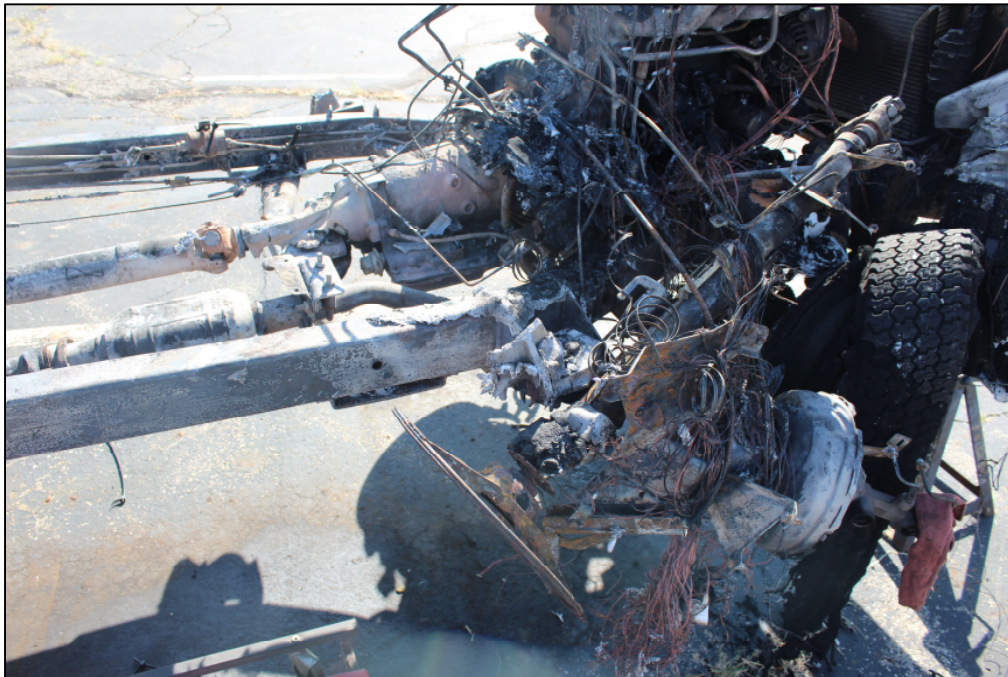
The interior was observed with severe fire damage and mass loss to all areas. The steering wheel and column were still attached to the frame. A small section of the rear cargo floor was in-place. All other interior components were consumed or severely damaged by fire and located in the trash containers.

Photograph 5
Driver compartment.

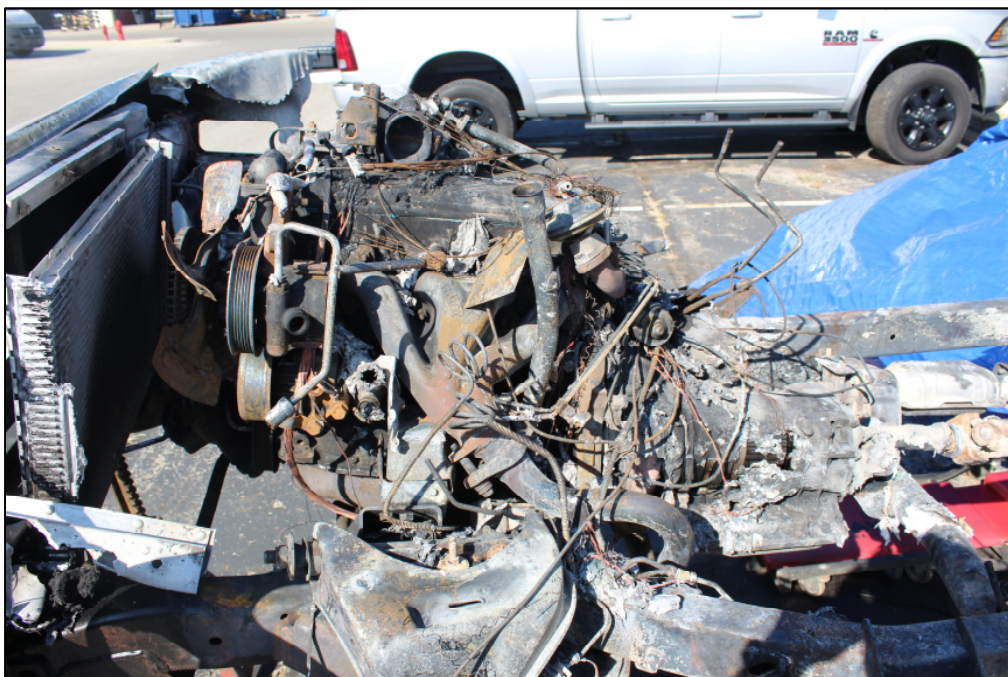
The engine and transmission were attached to the frame. The hood and fenders were consumed by fire. The entire engine was severely fire damaged. The left side of the transmission bell housing was fire damaged and fractured, with the left side housing missing. There was no fluid in the transmission. The engine oil dipstick was not accessible. The fuel lines were severely damaged by fire at the rear of the engine block. There was heat damage and oxidation on the exhaust pipe adjacent to the left side of the transmission. The battery was destroyed by fire. The vehicle was equipped with a GM 2.2L four-cylinder engine. The engine was a fuel injected throttle body design.

Photograph 6
Engine compartment.
